Surface Degradation Linked to Actuator Pin Fracture in Magnetically Controlled Growth Rods (MCGRs)

Institute of Orthopaedics and Musculoskeletal Science
University College London

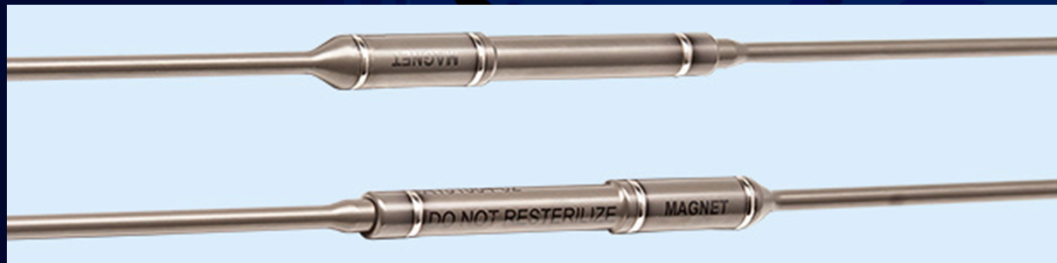
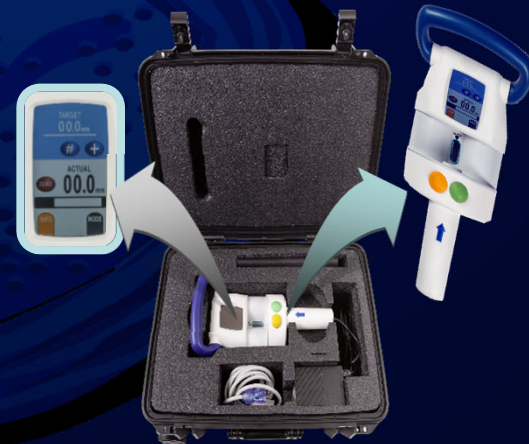
The Magnetic Growth Rod MAGEC™

- Obviates the need for repetitive surgery
- Outpatient lengthening
- Decreases Morbidities
- Decreases stress on parents and patients
- Reduces cost

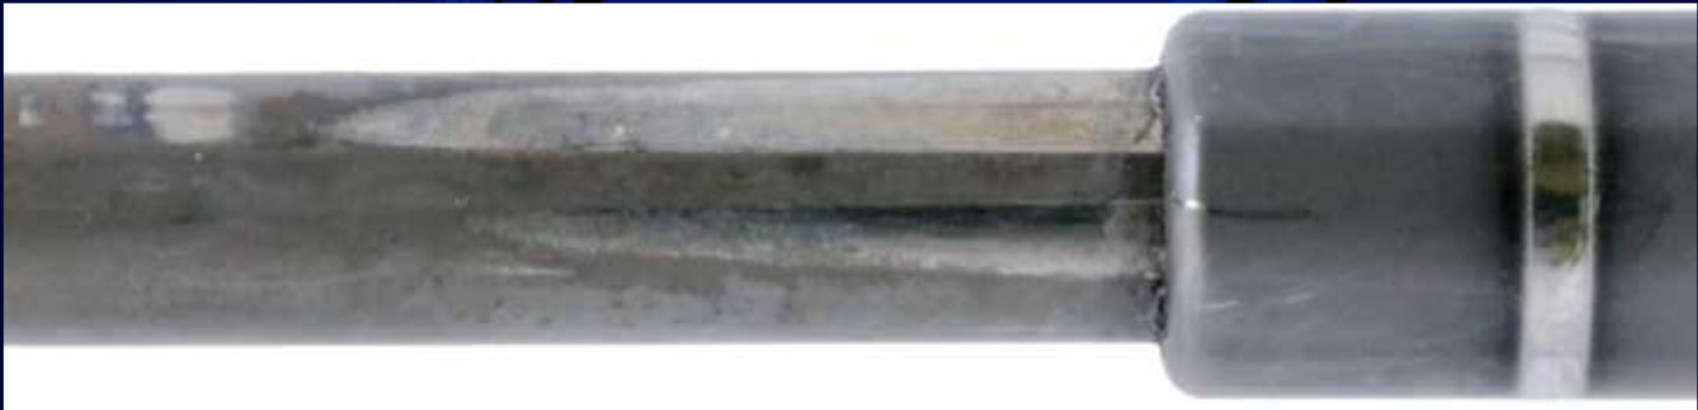
- All rods had surface damage on the actuator part, but damage appeared greater if pin fractured

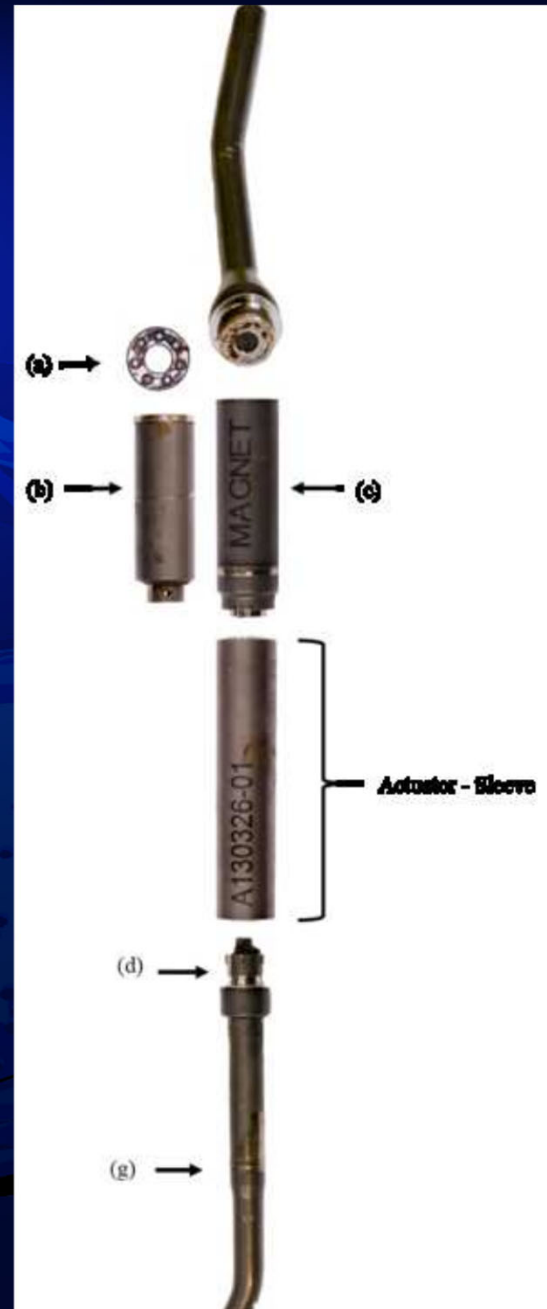
- We sectioned two rods:
 - one with pin fracture
 - one with intact mechanism
- to understand how they perform in situ

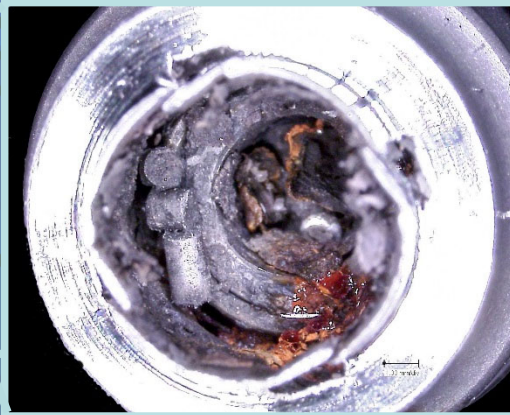
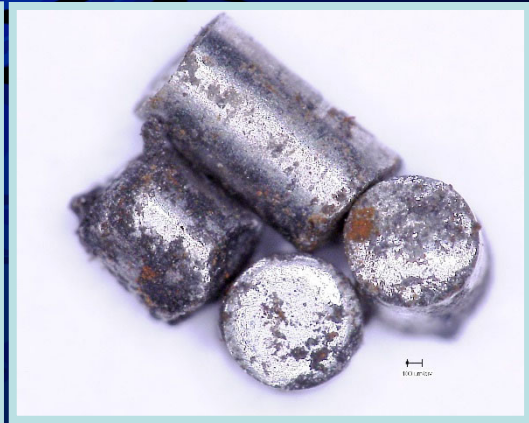
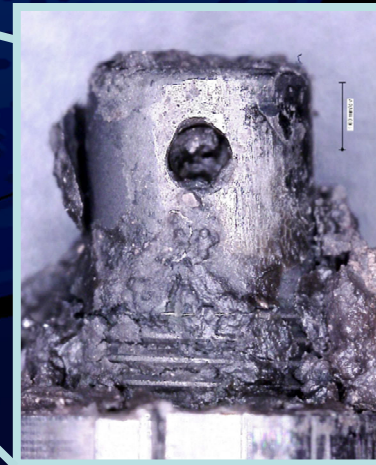
Body fluid ingress results in corrosion of the internal mechanism.

This corrosion can result in pin fracture.
